1. Project Name: Kahului DDH
2. Date of Inspection: August 14, 2007
3. Inspection Personnel:

O & M INSPECTION REPORT FOR NAVIGATION PROJECTS

Honolulu Engineer District

KAHULUI HARBOR, MAUI, HAWAII

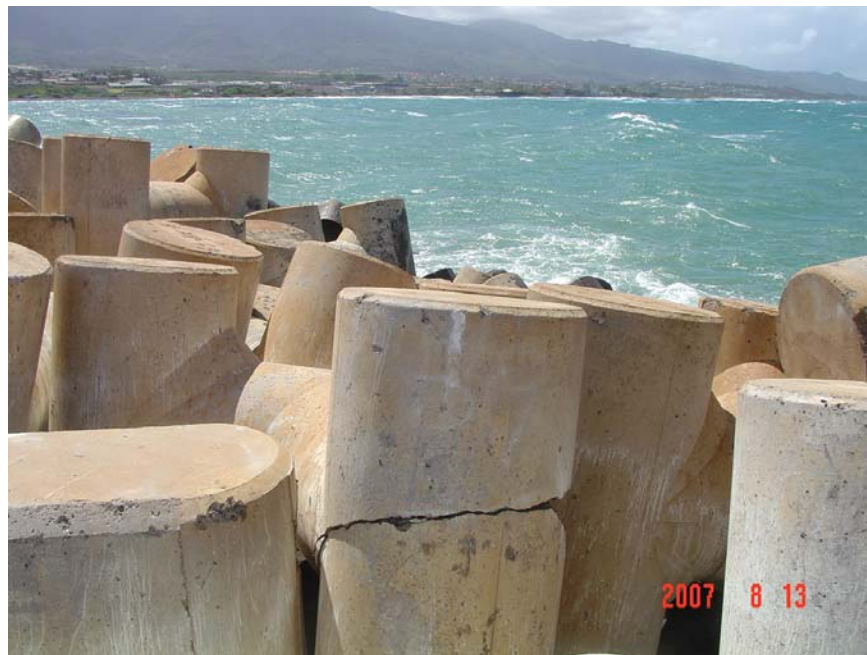
l. Sta. 21+50, OS, (Rib 47), Broken Tribar, adj ribcap.

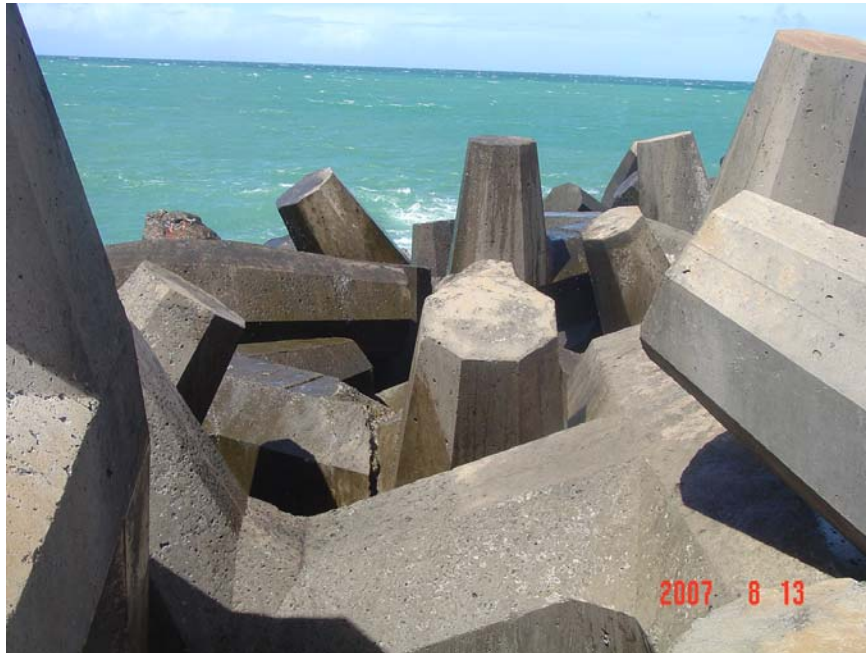
m. Sta. 21+42 to 21+60, OS, 4 broken dolos/tribars, end of turn around.

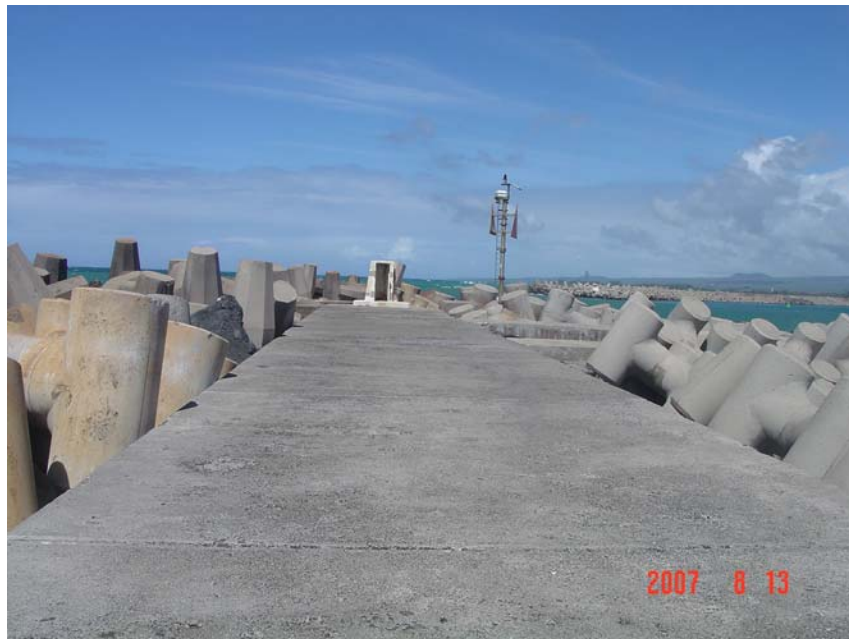
n. Sta. 21+60, End of ribcap.

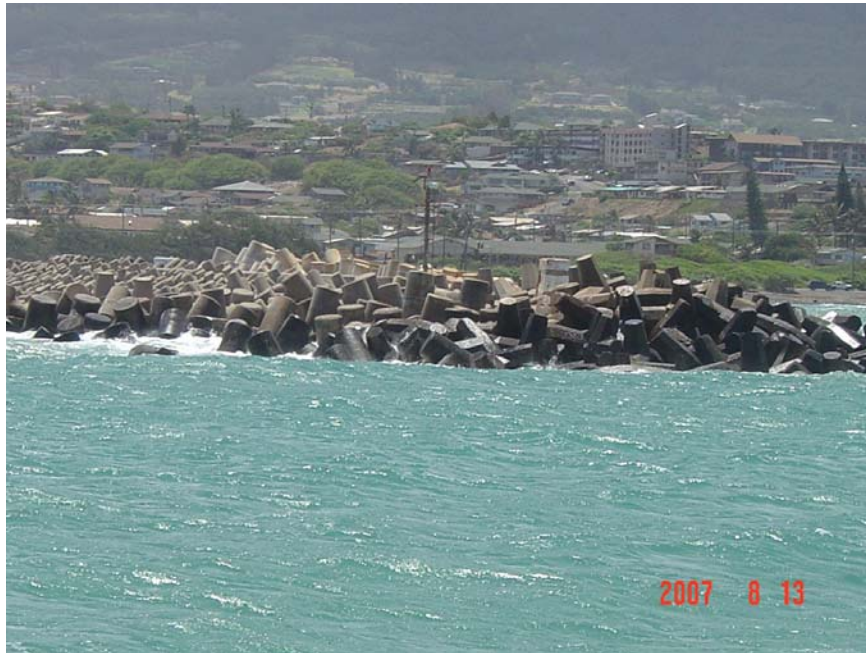
Head of West Breakwater.
